**RAILWAY ACCIDENT INVESTIGATION  
REPORT**

**Occurrence of casualties among passengers of 7 up Tinsukia Mail train at Km./77/3-4  
between Pathsala and Tihu Stations on the Single Line New  
Bongaigaon Gauhati Metre Gauge Section of  
Alipurduar Division of Northeast  
Frontier Railway at  
13-09 hours**

**12 th March, 1981**

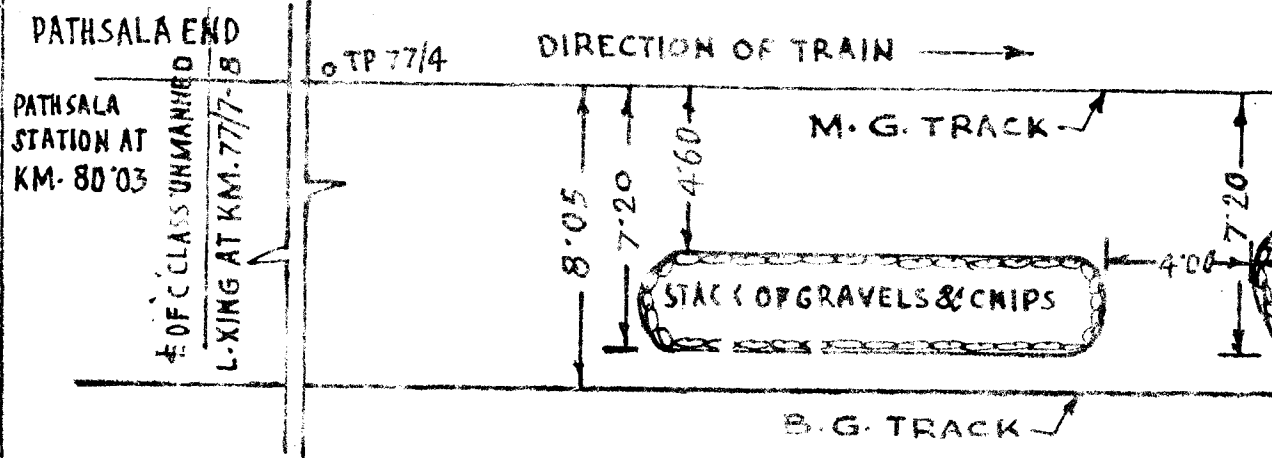
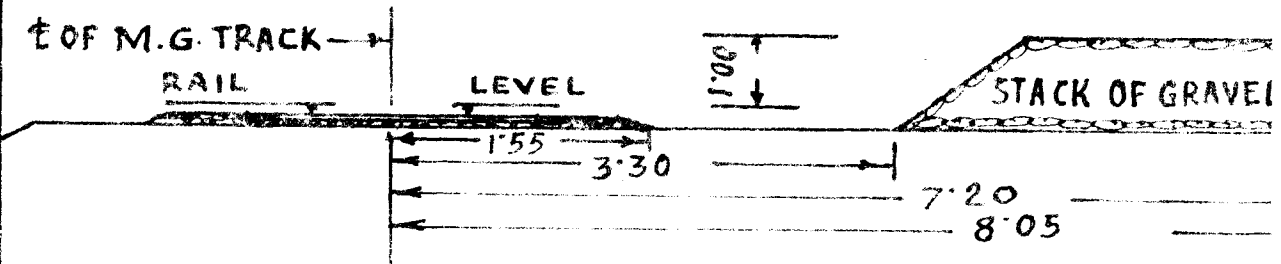
SECTION ON A-B  
SCALE:- 2CM=1M.

6.1.2 It was explained by the Executive Engineer (Con) that when the earlier trips were unloaded in the presence of the IOW, the trucks were unloaded by stopping them about 60 metres short of the Bridge No. 483 and well clear of the line demarcated at 2.5 m. from the centre line of M.G. track. The unloaded material was then carried forward by manual labour and stacked. However the particular truck which caused the accident, having come there for a first time, seemed to have stopped in the 3.3 m. distance between the metre gauge track and the stacks already made.

In this position it was observed that the truck would be fouling the moving dimensions of the metre gauge track.

6.1.3 It was stated by the Divisional Engineer that soon after the accident some wheel marks were found on the ballast shoulder of the metre gauge track at a distance of 1.5 metres from the centre line of the track. The truck standing in this position would have fouled the metre gauge track sufficiently to have been hit by the locomotive and to be smashed up. Therefore these marks should have been made while the truck came in before and went back soon after the accident.

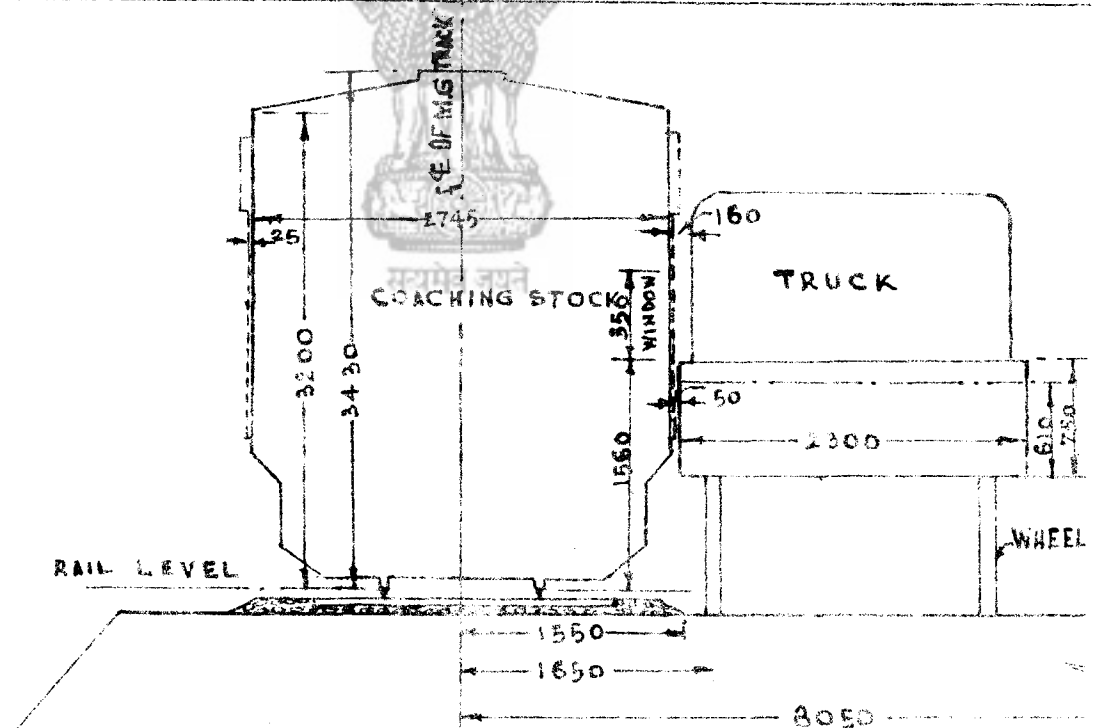
SECTION SHOWING PROBABLE POSITION OF COACH AT  
AT THE TIME OF ACCIDENT.  
SCALE - 2CM = 1M.

fouling the metre gauge track. In the present case the truck was close enough to cause injuries to passengers who had kept their limbs projecting outside the window but it was far enough not to come in contact with the body of the coach.
